# Using a vermiculite-based fire protection mortar to increase the fire resistance of reinforced concrete tunnels

**ABSTRACT:** The mechanical properties of reinforced concrete elements tend to be damaged and weakened after they have been exposed to a significant fire, leading to a thinner alkaline protective coating around steel reinforcement, as well as a reduction in the yield and stiffness of the steel. In tunnels, fire can increase the concrete temperature extremely rapidly, as the heat generated cannot escape, resulting in high vapor pressures within the concrete structure, which in turn leads to explosive spalling and a significant loss of strength, potentially endangering human lives. In this study a series of experiments was conducted to evaluate the performance of a specific lightweight fireproofing material in terms of its behavior in fire. Test specimens were produced and tested in accordance with exposure under the RWS fire curve up to a temperature of 1,350 °C as outlined in EFNARC guidelines, then the passive protection provided by the product was evaluated for various layer thicknesses and exposure times. To further substantiate these laboratory findings, a full-sc

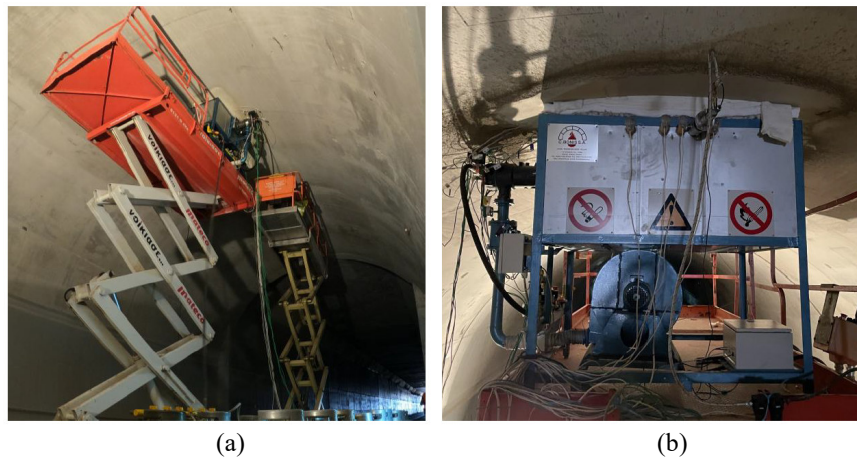
Figure 1. (a) Application of Sikacrete<sup>®</sup>-213 F to the tunnel crown and (b) furnace for site fire resistance testing in the Panagopoula twin railway Tunnel.

At the Panagopoula railway tunnel test site, thermocouples were installed on the crown / internal roof of the tunnel in the layout described in the EFNARC guidelines for large scale tests (EFNARC, 2006). In total, nine thermocouples (Type K) were fixed on the tunnel crown; four thermocouples were fixed at the interface of concrete and the fire protection mortar, and five thermocouples were fixed 50 mm inside the concrete at the level of the steel reinforcement. After installation of these thermocouples, the fire protection mortar was applied by the wet spray method, to the designed thickness of 15 mm over an area of approximately 125x125 cm<sup>2</sup>, then the testing was conducted 56 days after the mortar application. With regard to the thermocouples exact locations; TC1, TC2, TC8 and TC9 have been installed at the concrete and fire protection mortar interface, whilst thermocouples TC3, TC4, TC5, TC6 and TC7 have been installed 50 mm below the concrete surface to represent the steel reinforcement position, again all in accordance with EFNARC guidelines (EFNARC, 2006).
